**DESIGN AND ACCESS STATEMENT**

**FOR RE-ROOFING TO  
CREEKSEA PLACE  
FERRY ROAD  
BURNHAM-ON-CROUCH**

**HISTORIC BUILDINGS  
ASSESSMENT**

**HISTORIC BUILDINGS ASSESSMENT**  
CREEKSEA PLACE  
ESSEX

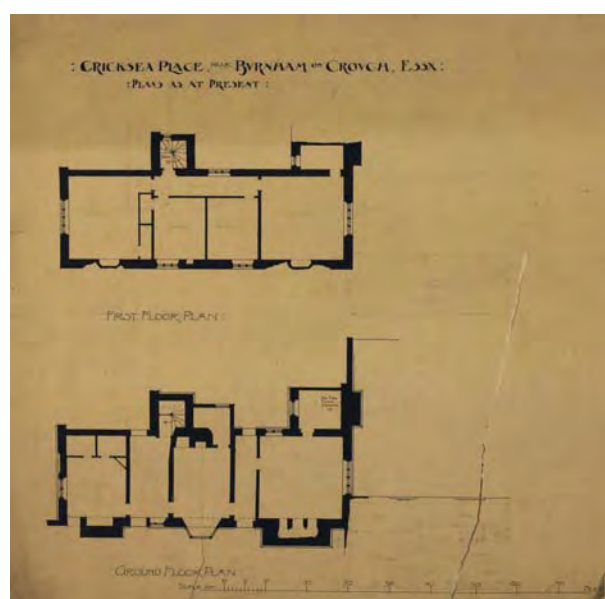
**Plate 8** Ground and first floor plans of the house, dated 1900

William Rome (1842-1907) was the son of Andrew Rome, a police inspector who was responsible for policing the oyster fisheries on the River Crouch. On leaving school, William Rome joined Sweetings, one of the larger local oyster merchants, but illness resulted in him leaving work and the opportunity to travel around on the continent. His travels inspired an appreciation of fine art, and he returned to England with an extensive collection of art and china. Rome eventually became a senior partner in the Sweetings business. He rented and moved into Creeksea Place in 1899 following marriage difficulties with his second wife, and purchased the house outright in 1900/1901 and remained there until his death in 1907 (Fairman 1985). The layout of the house at the time of his purchase can be traced from a series of plans prepared in 1900 (Plates 7 and 8; see Appendix F).

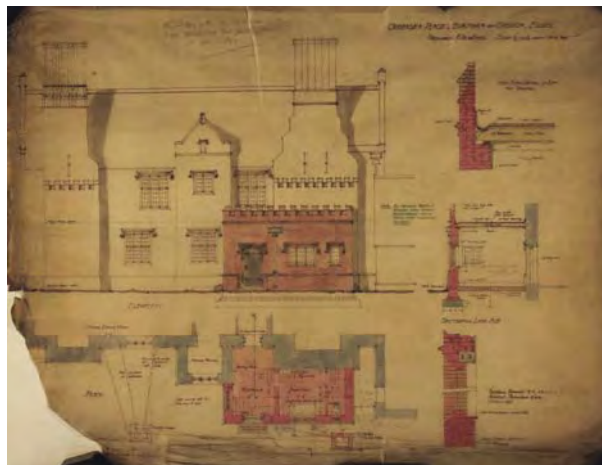
**Plate 16** Proposed north lavatory block, 1918

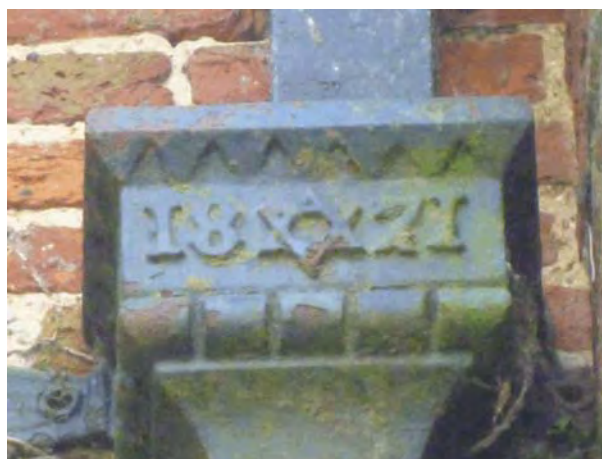
**Plate 17** Rainwater hopper dated 1871

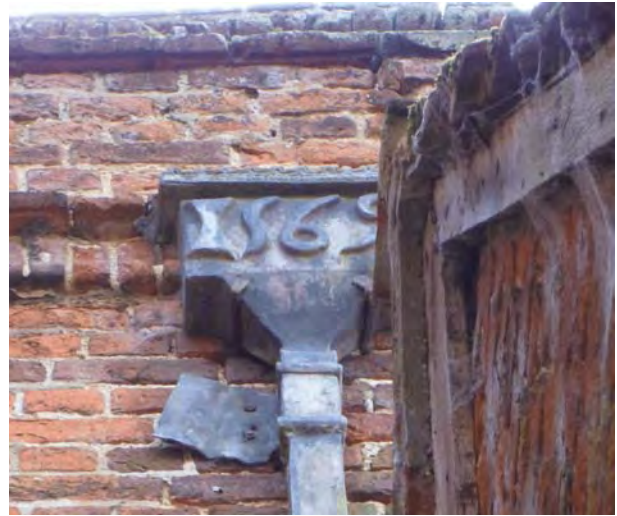
**Plate 18** Rainwater hopper dated 1569

The first floor window (WF5) is of identical form to that on the ground floor (WG5), although most of the brickwork associated with it appears to have been replaced in the early 20th century. To the west of the window the 16th-century fabric is covered with early 20th-century blocks and only a small section is exposed adjacent to the gable end. The main features in the latter portion are a short section of exposed moulded brick stringcourse (which extends around onto the west elevation) and a lead rainwater down pipe which, on the hopper, has the date 1569 cast into it (Plate 18). The hopper cuts into the brickwork forming the moulded

string course and appears to be a later insertion, either dating to 1569 or having been moved to its current location at a later date. To the east of the hopper, and subsumed behind the early 20th-century additions to the elevation, is a further original chimney. Like its compatriot to the east it has been provided with three octagonal shafts.

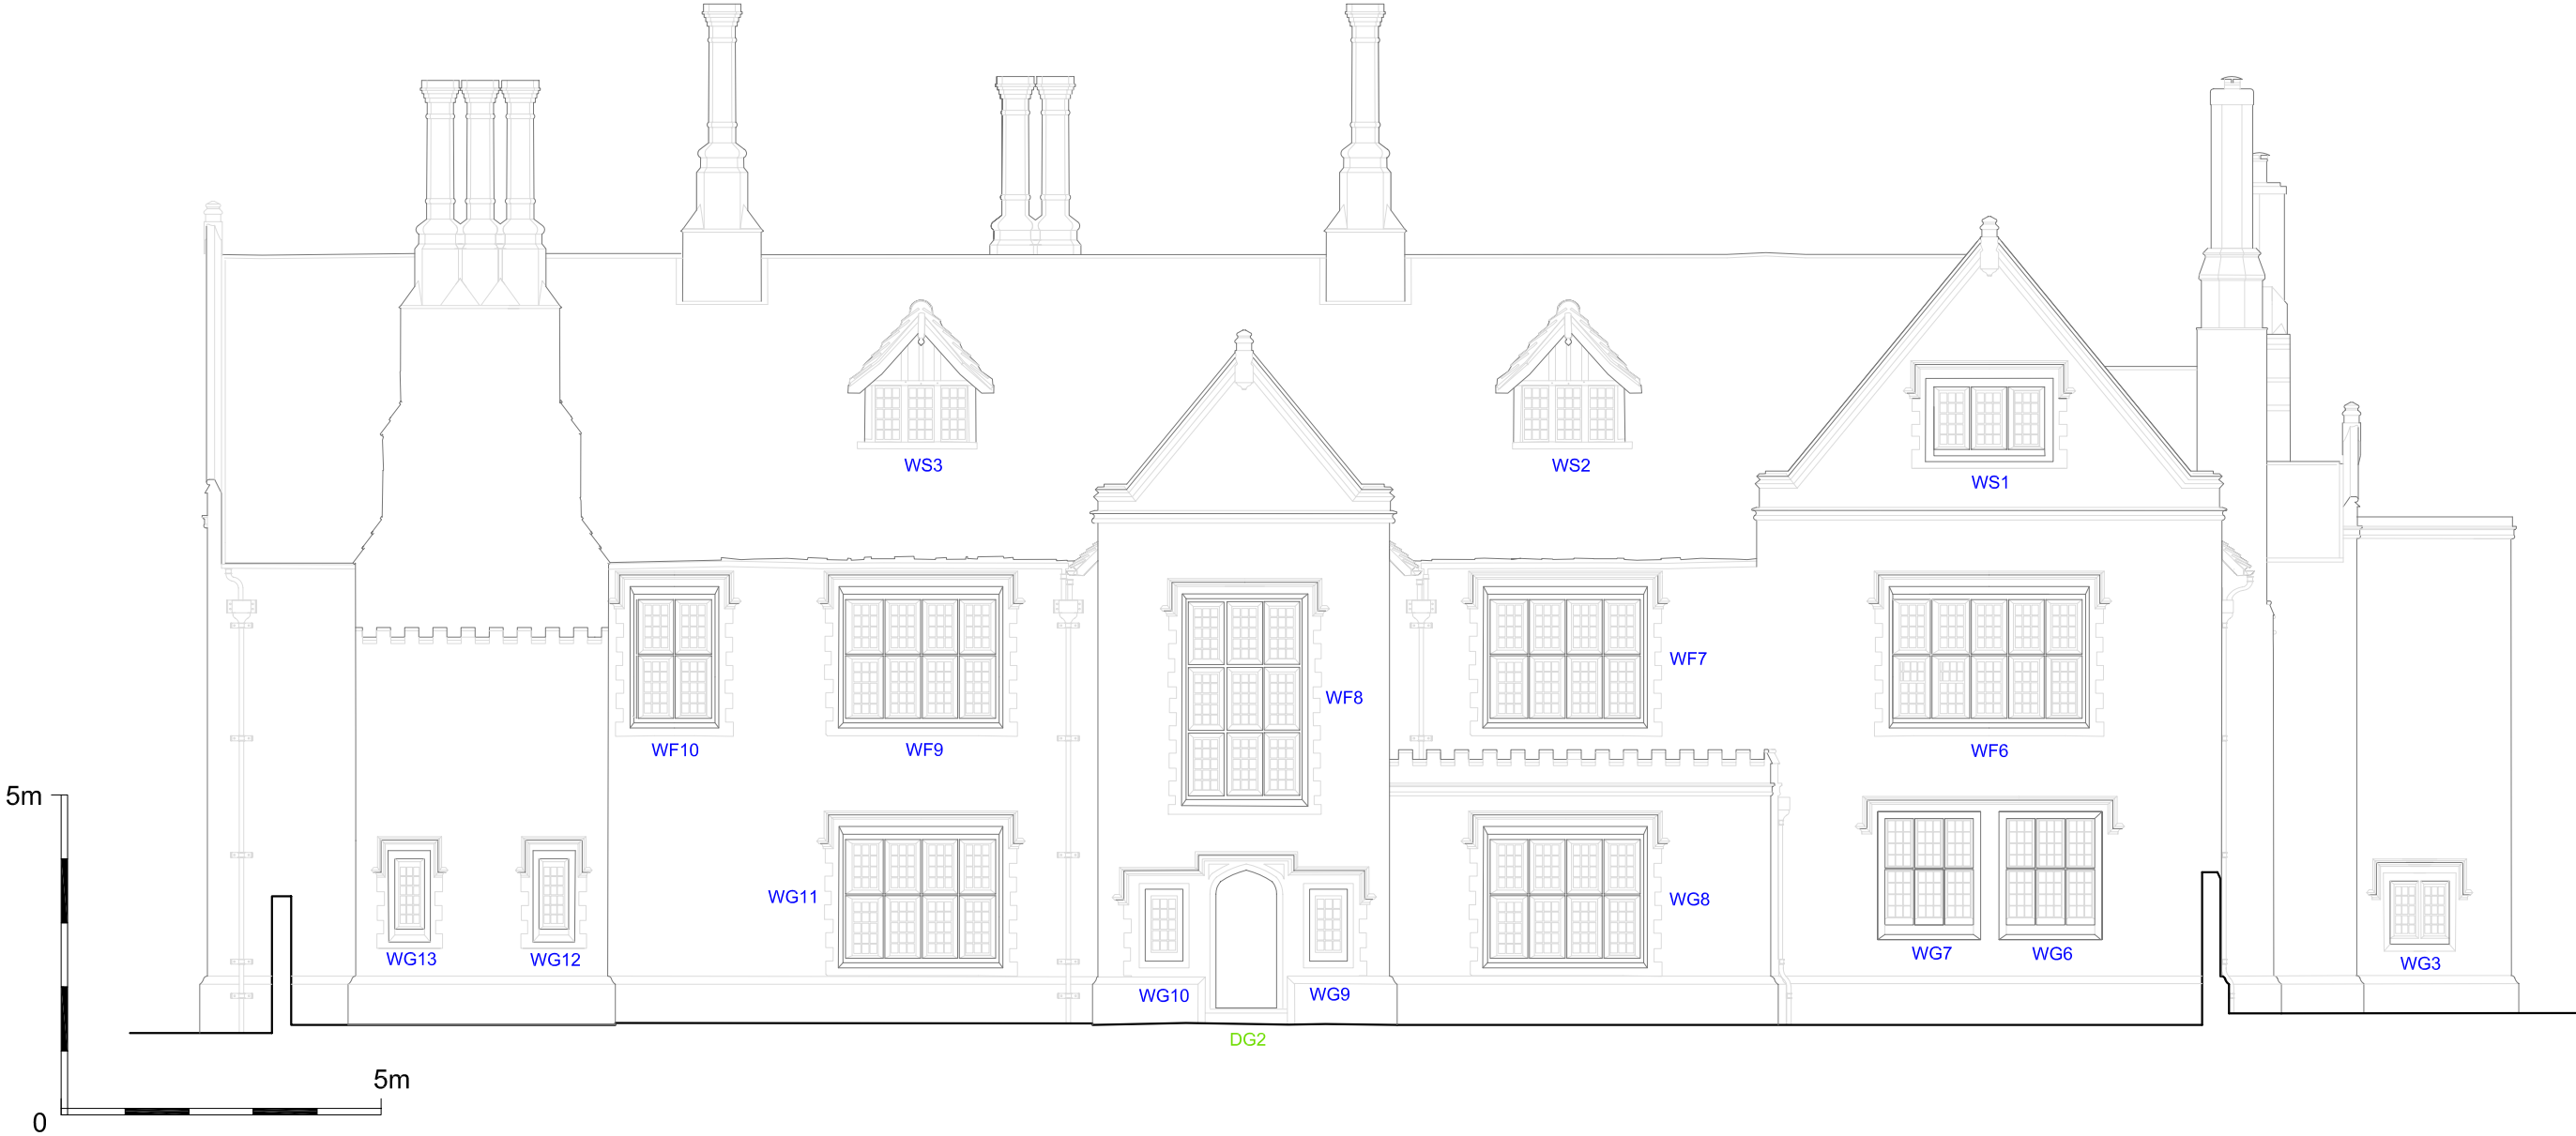
Figure 3

East elevation

The east elevation (Figure 3) would have been the original principal main facade of the house in the 16th-century, but the demolitions of the 1740s left only the east elevation of the north range standing. William Rome rebuilt the east range of the house in c.1901 in a free interpretation of what the 16th-century house might have looked like.

The majority of the east elevation consists of that rebuilt by William Rome in c.1901 and consists of a long three-storey facade with a projecting entrance porch and, at the south end, chimney. The detailing closely emulates the 16th-century work with mullioned and transomed windows under labels.

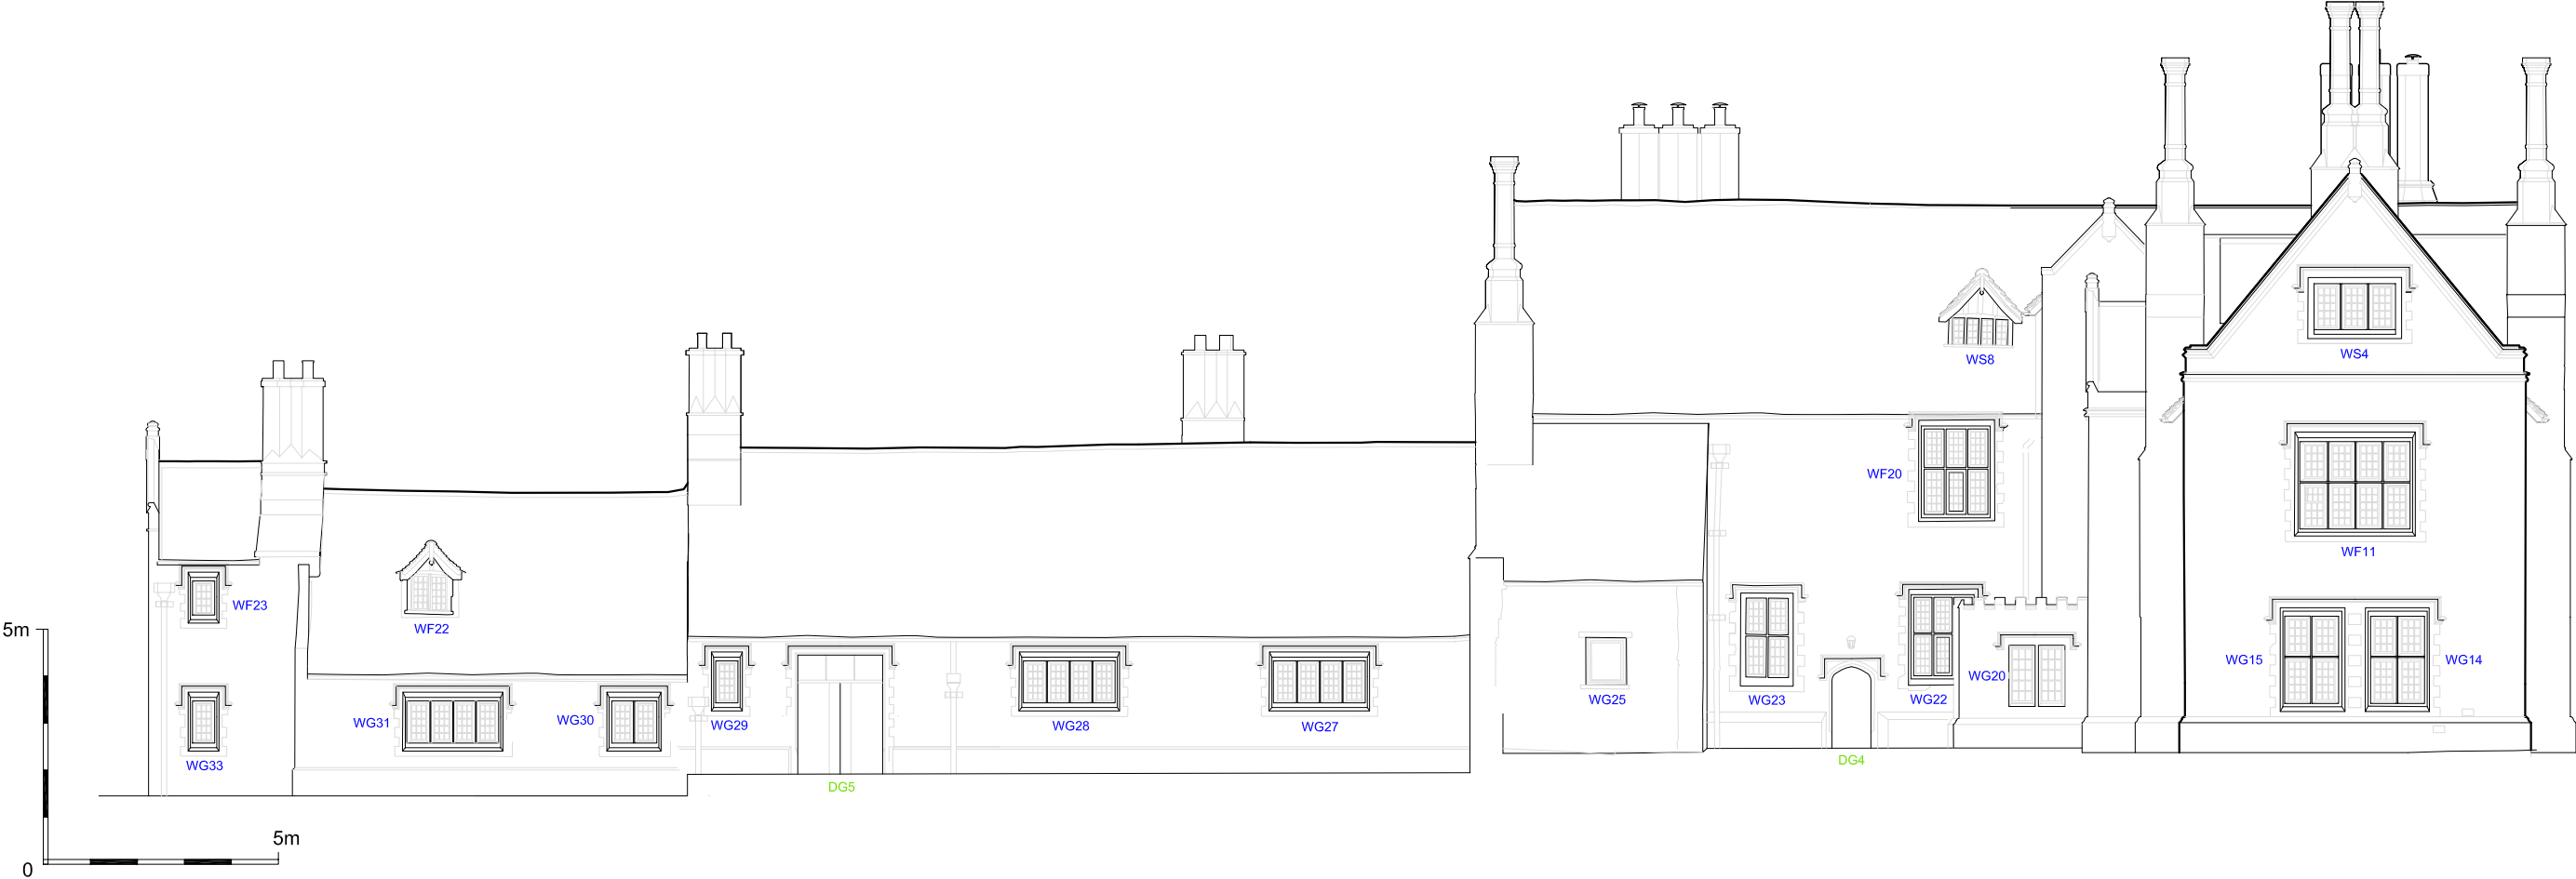
Figure 4

South elevation

The south elevation is composed of the gable wall of the c.1901 east range, and the south walls of the 16th-century north range and north range extension (Figure 4).

A single dormer window has been provided at second floor level (WS8). Of four-lights, the window might be an original 16th-century feature although much repaired.

The wall head would probably have terminated with a string course and low parapet wall but this appears to have been removed to allow the roof to over-sail the wall head; probably an alteration of the 18th or early 19th century.

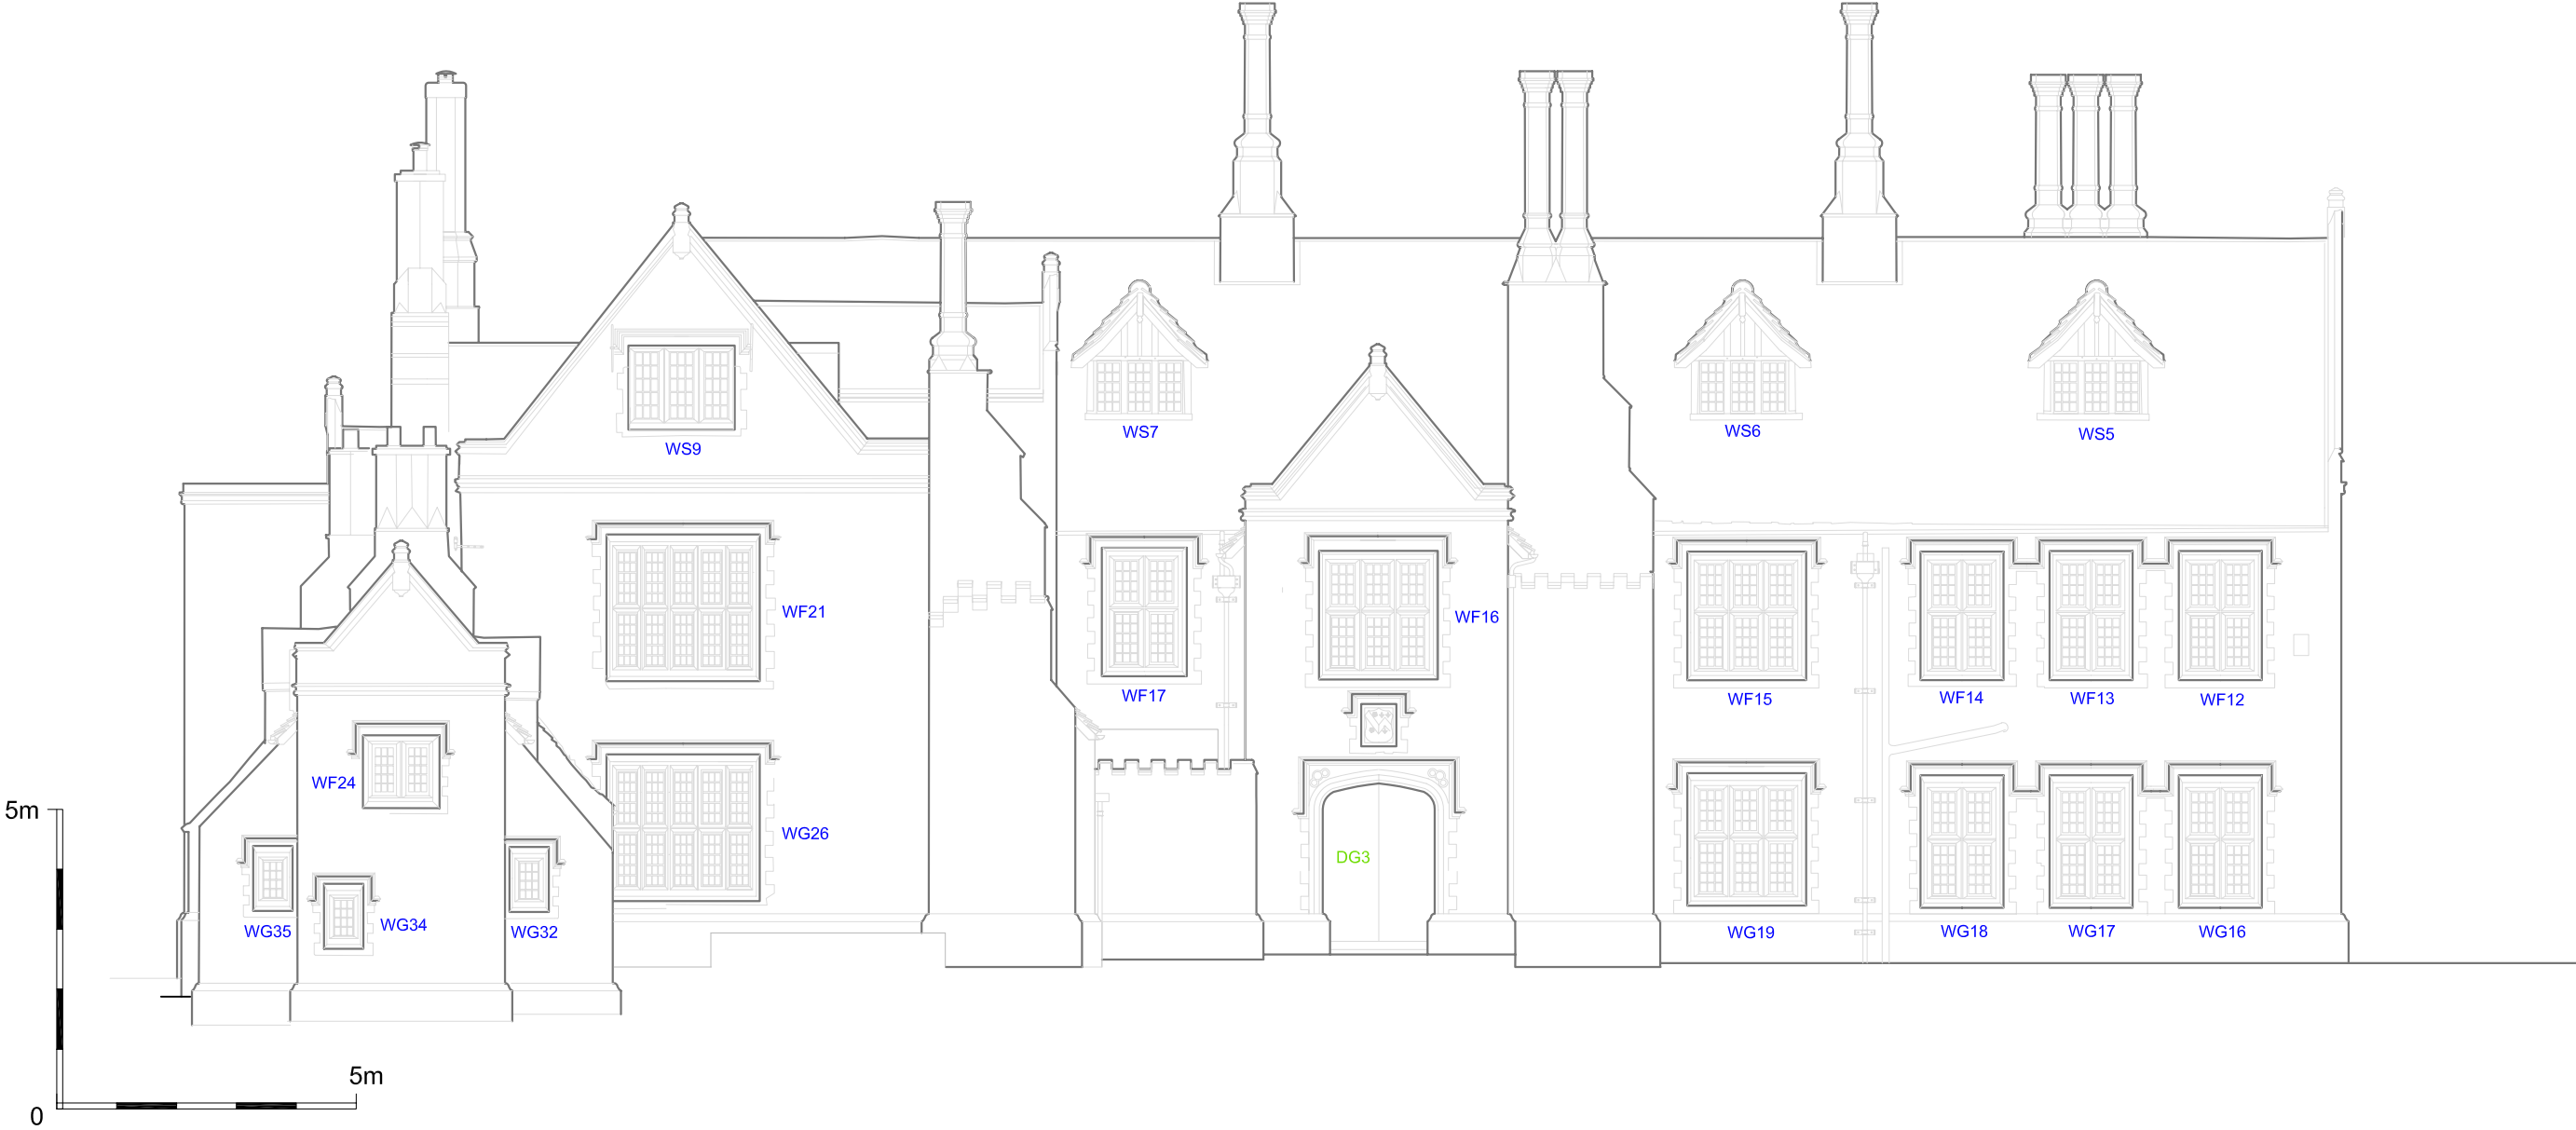
Figure 5

West elevation

Most of the west elevation is the work of William Rome in c.1901 consisting of the rebuilt east range (Figure 5). Detailing to this portion of the fabric is as on the east elevation, but incorporates a door opening with a porch.

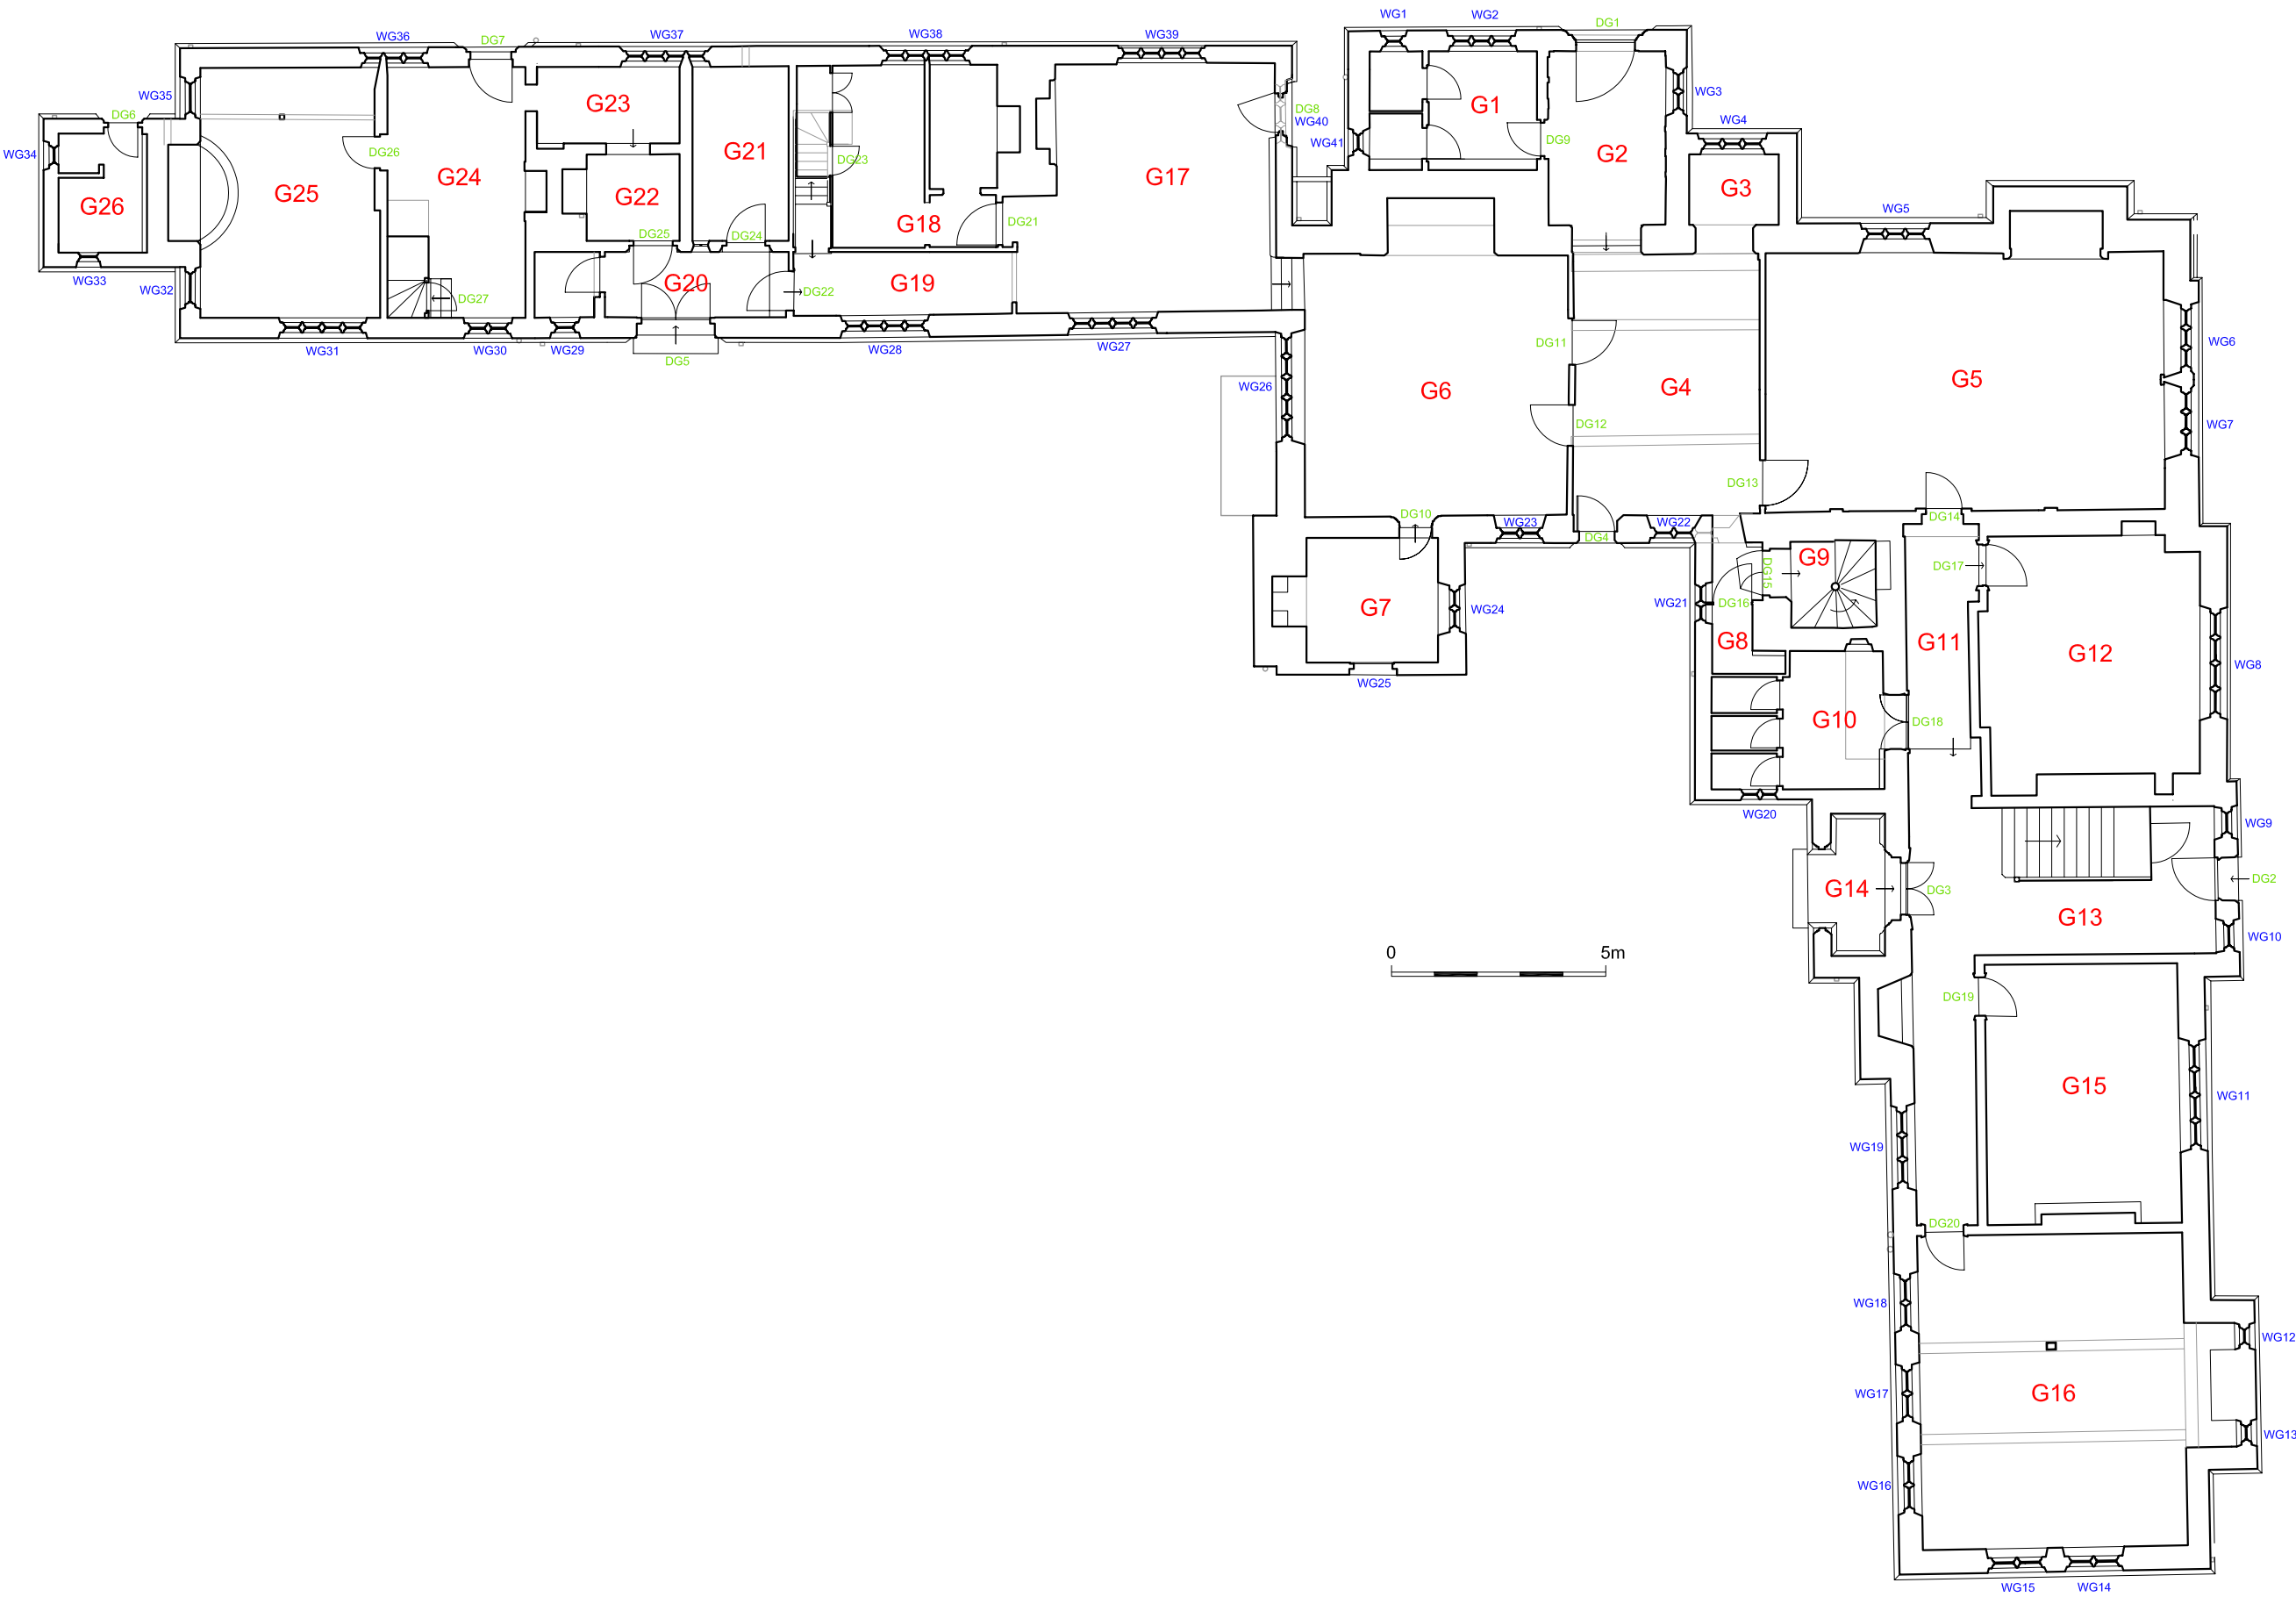
Figure 6

Ground-floor plan

The house is now generally entered through the main door on the north elevation (DG1). Rooms G1 to G3 (Figure 6) are all late additions to the house of c.1918. Room G1 serves as an entrance hall and has been lined with fake (c.1918) timber-framing to provide an air of antiquity. A door through the west wall leads into Room G2, now a cloak room, described as a 'lavatory' in 1918 when it contained three wash basins. The most notable feature in the room is the south wall which retains the formerly exterior plinth which runs around the large chimney breast of Room G6. Room G3 is on the east side of Room G2 but is accessed through Room G4; it has no particular features of note.

Room G4 is part of the 16th-century phase of the house with its east and west walls formed from timber-framed partitions. The west timber-framed wall appears to be original although it has undergone some alteration. The west wall now has two door openings (DG11 and DG12); that to the south, DG12, appears to be an insertion of late 17th- or 18th-century date judging by the moulding on the surround, while the northern door, DG11, is original work of the 16th century and has a deep chamfered surround with stops. The RCHME plan of the house indicates that the latter door was blocked and the former door was open at the time of their survey, in addition to identifying the entire wall as modern (RCHME 1923, 28). The east wall also incorporates a door opening (DG13) of

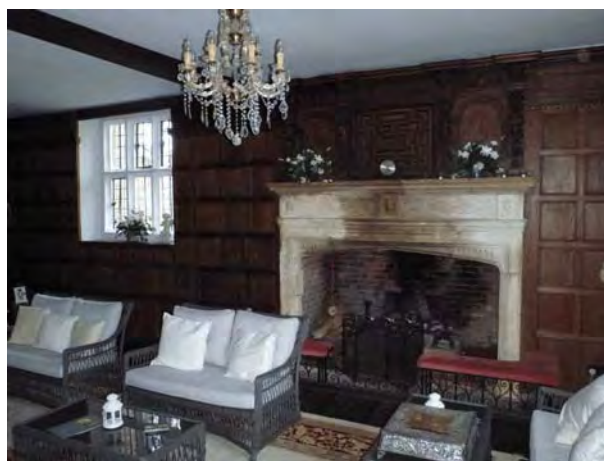
**Plate 19** Room G5

The current appearance of Room G5 is entirely due to the alterations made by the Jacksons in c.1918. It has been lined with panelling of 17th-century date, with additional moulding details added which appear to date from 1918 (Plate 19). According to the RCHME plan of the house, there was south to north sub-dividing wall through the room which provided a near square room at the east end and narrow room or passage at the west end. However, the current window disposition within the room reflects the original layout although the north window, WG5, has been widened. The position of

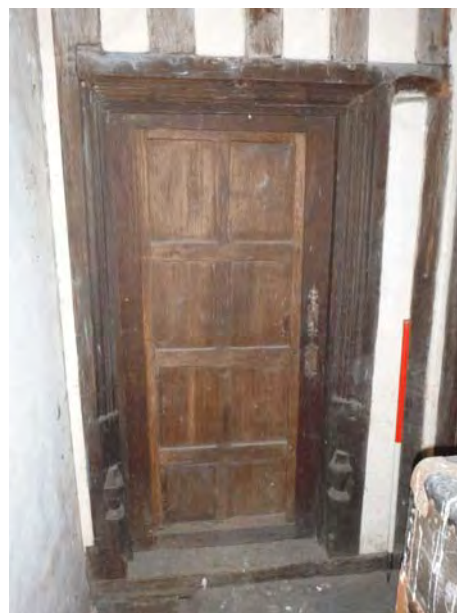
**Plate 21** 16th-century door opening into F20

At the west end of the corridor is a further ornate 16th-century door opening (DF14) which leads into the west end of the north range (Plate 21). The west end of the north range is occupied largely by a single large room (F20). The east, south and west walls of the room are lined with 16th or early 17th-century timber panelling. It is evident that the north wall had a similar treatment although most of the panelling has been removed. Within the north wall is an original 16th-century fireplace and, above it, a substantial steel joist has been inserted into the wall presumably to deal with structural problems in this area. A door opening in the east wall (DF13) houses a ornate carved panelled door of probable 16th century date. It is unclear whether the door is original to the house or a feature that was introduced by William Rome. An examination of the floor boarding on the eastern side of the room reveals a uniform junction in the floor boarding running north to south, which might suggest a partition has been removed. Given that the current east wall of the room appears to be original timber-framing, a further partition to the west of it would provide for a narrow room along the east side of F20. Such a narrow room is unlikely to have been a corridor, as it would not have led anywhere, and is more likely to have been a closet.

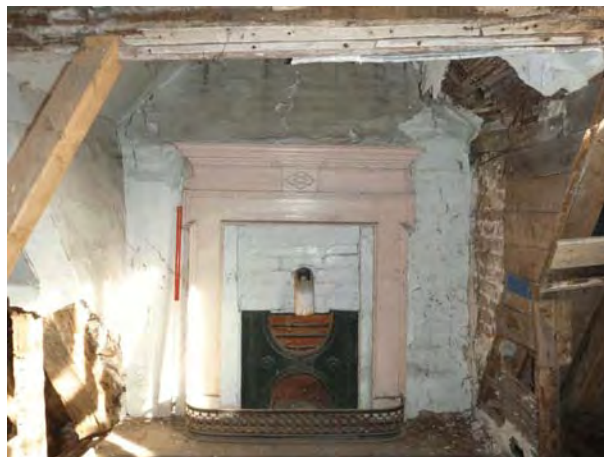
**Plate 22** 18th-century fireplace in S5

Rooms S1 to S5 form the top floor of the original north wing. S1 to S3 originally formed a single central room the north side of which was divided off in 1900s to provide space for water tanks and cupboards. Rooms S4 and S5 occupy either end of the north wing and entered through original 16th-century door openings. The main features of both rooms are fireplaces of 18th century date set in the north walls (Plate 22). It is likely that both S4 and S5 were intended as servants accommodation in the 16th and 17th centuries and typical

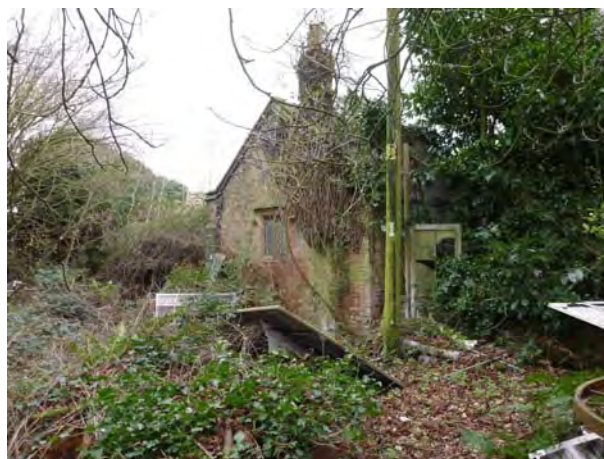
**Plate 23** Stable and carriage house

The stable block is located to the east of the house and, with other buildings, is now under a mass of vegetation (Plate 23). The two blocks would have formed a carriage house and stable and appear to have been erected before William Rome's restoration of the house. However, their architectural styling is very similar to Rome's work and it is possible that the work was designed by the same architects. Several additional buildings are attached to the stables, including an open cart shed, now in advanced state of decay.

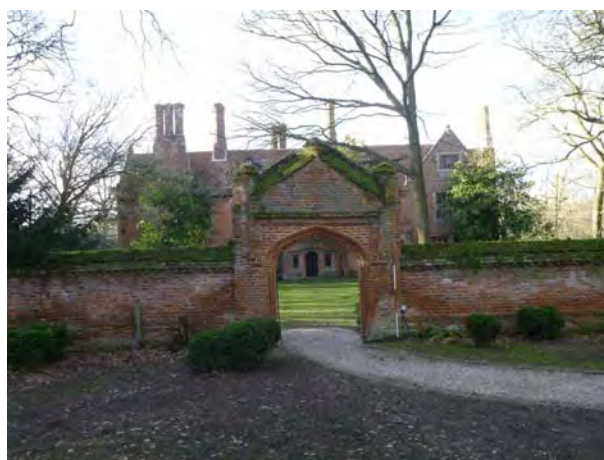
**Plate 24** East court gateway

Attached to the east side of the house is the East Court which largely retains its original 16th-century enclosing walls, gates and corner turrets (Plate 24). The East Court would have formed the original main approach to the house. The court is entered through a gate in the east wall with a four centre arched head under a moulded label with a pediment and corner turrets above. Internally, the opening retains the pintels for hanging a pair of gates with one pintel retaining a the ironwork that was fixed to the gate.

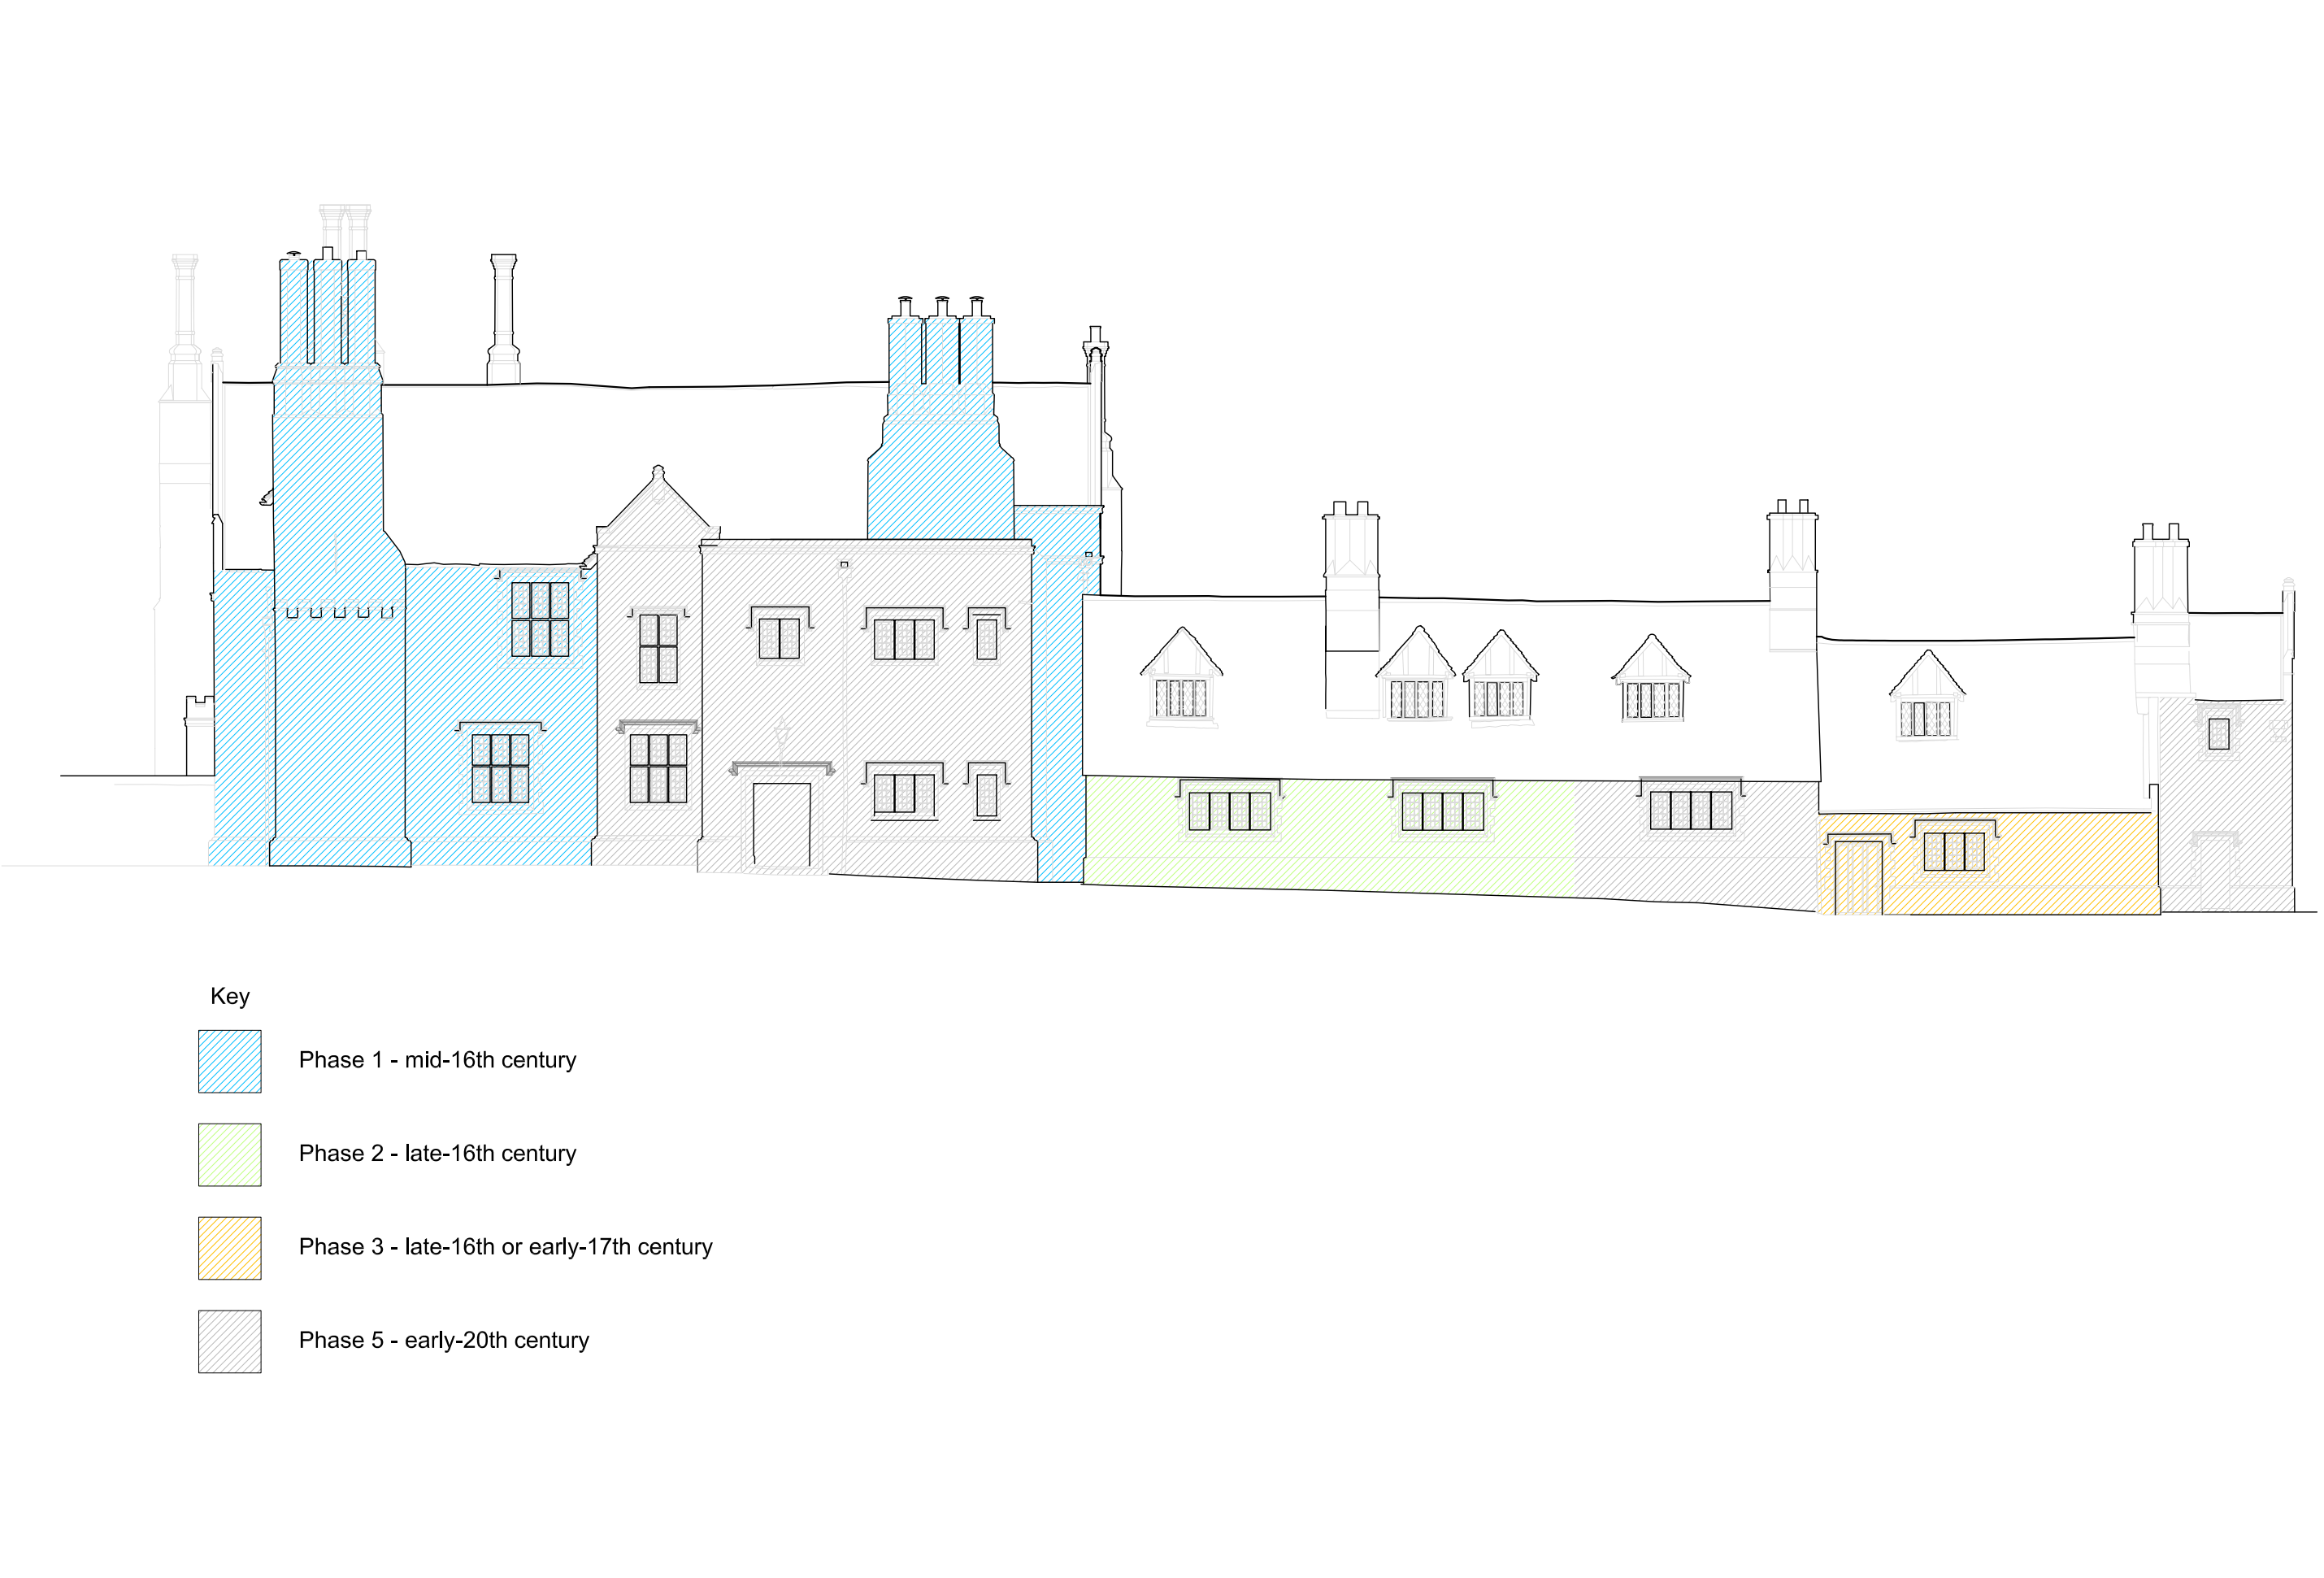
Figure 9

Phased north elevation

## **5.0 PHASING AND ANALYSIS (Figures 9 to 16)**
