**DESIGN AND ACCESS STATEMENT**

**FOR RE-ROOFING TO  
CREEKSEA PLACE  
FERRY ROAD  
BURNHAM-ON-CROUCH**

**HISTORIC BUILDINGS  
ASSESSMENT**

**HISTORIC BUILDINGS ASSESSMENT**  
CREEKSEA PLACE  
ESSEX

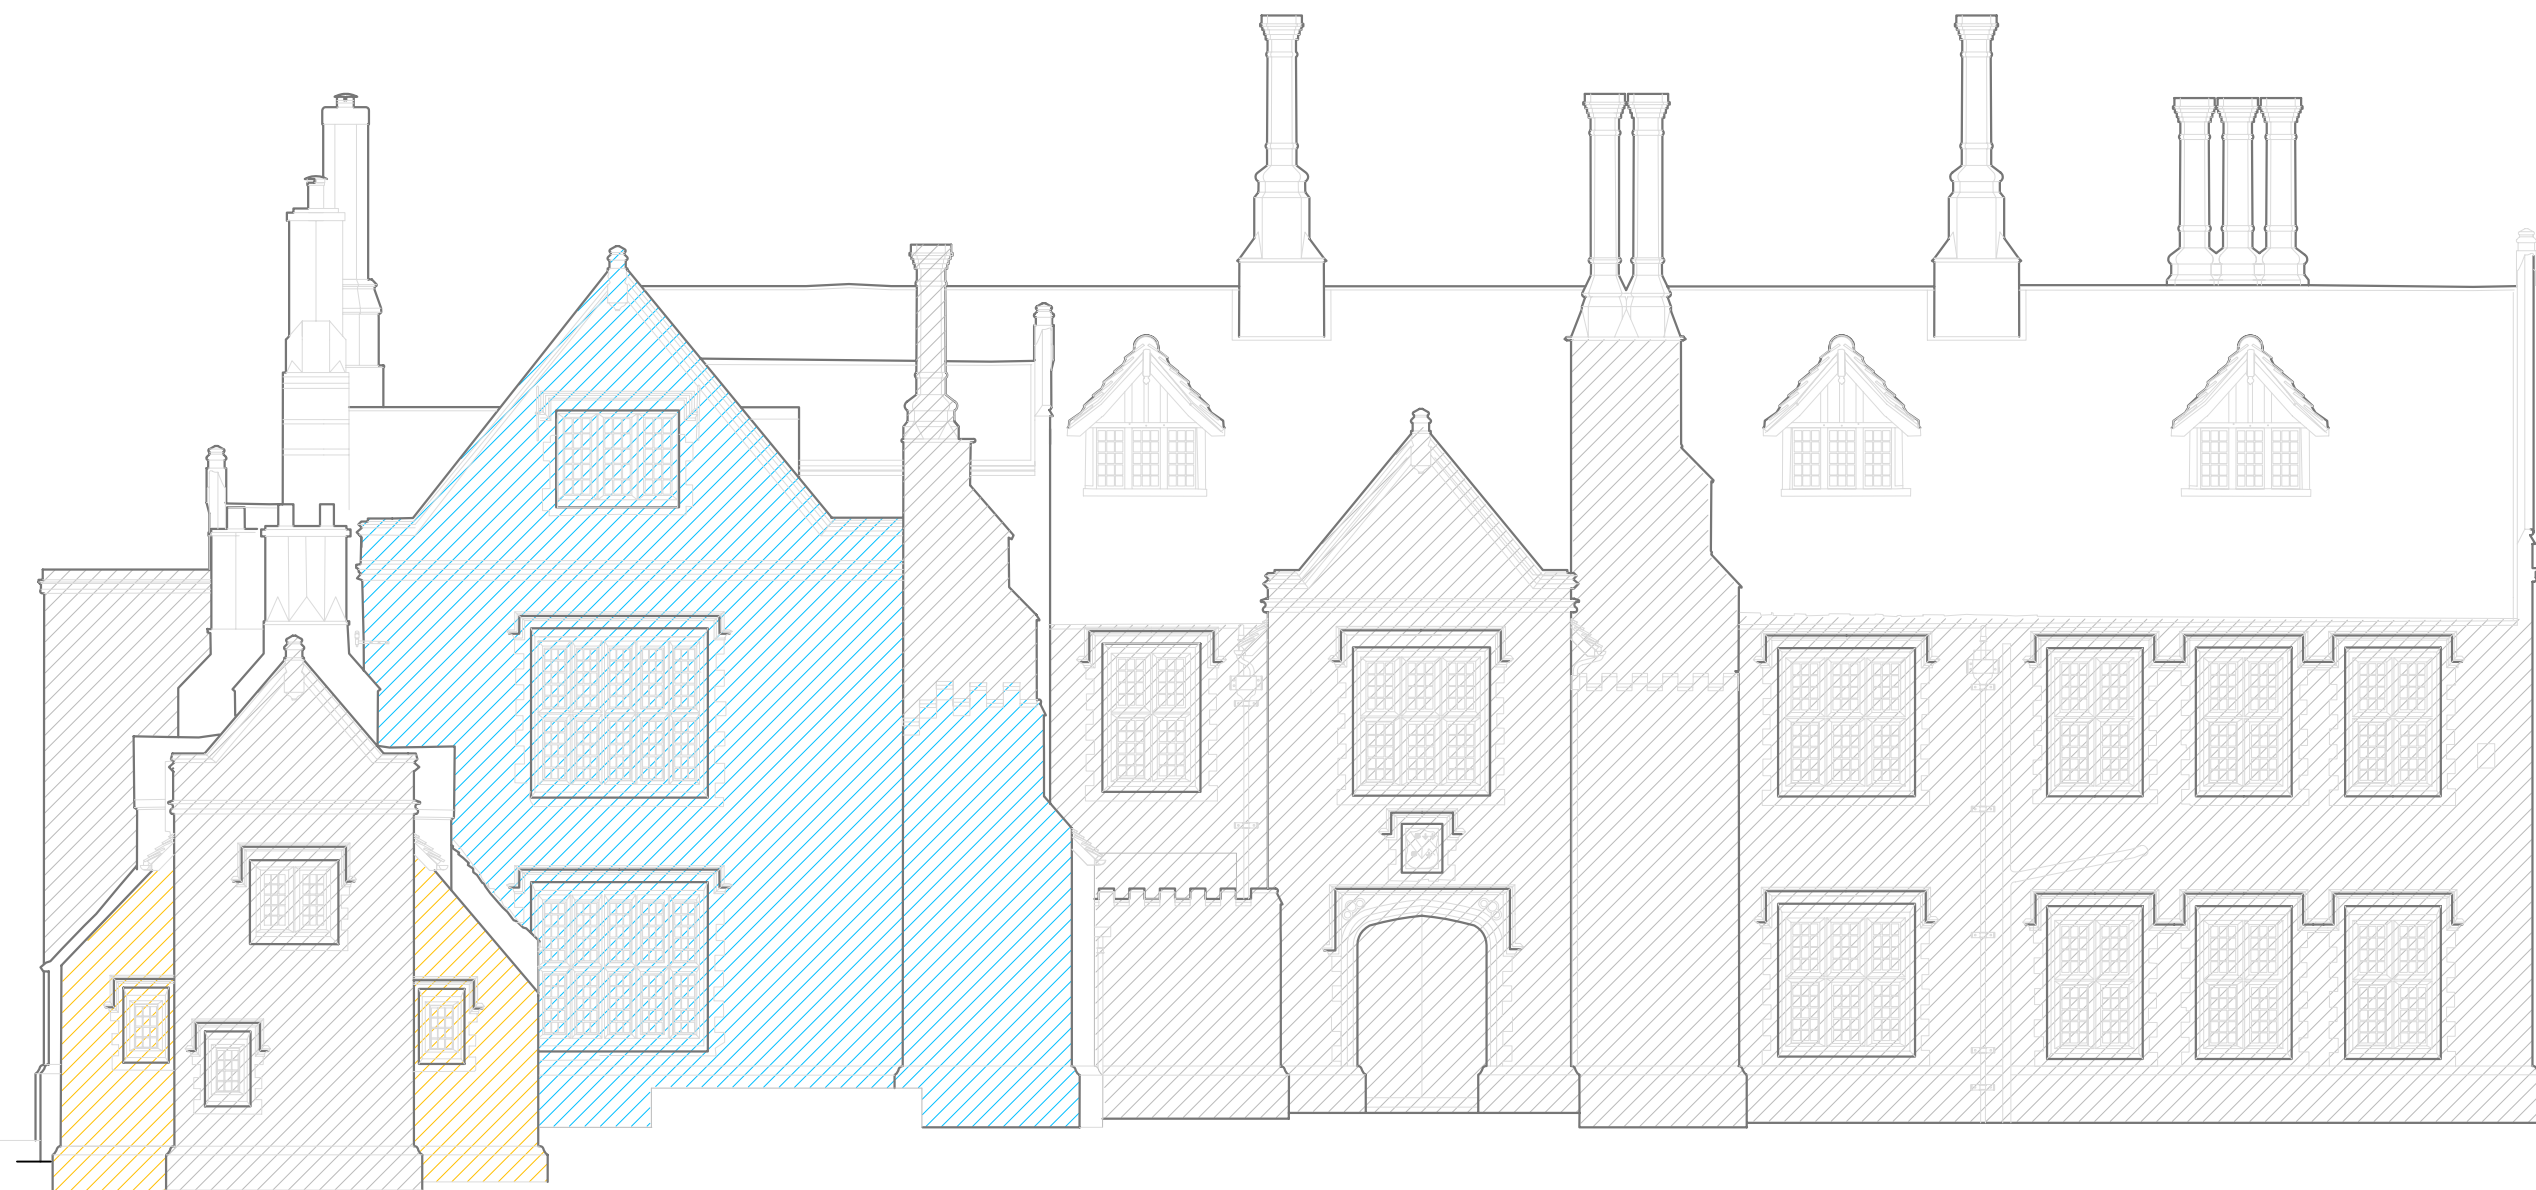
Figure 11

Phased south elevation

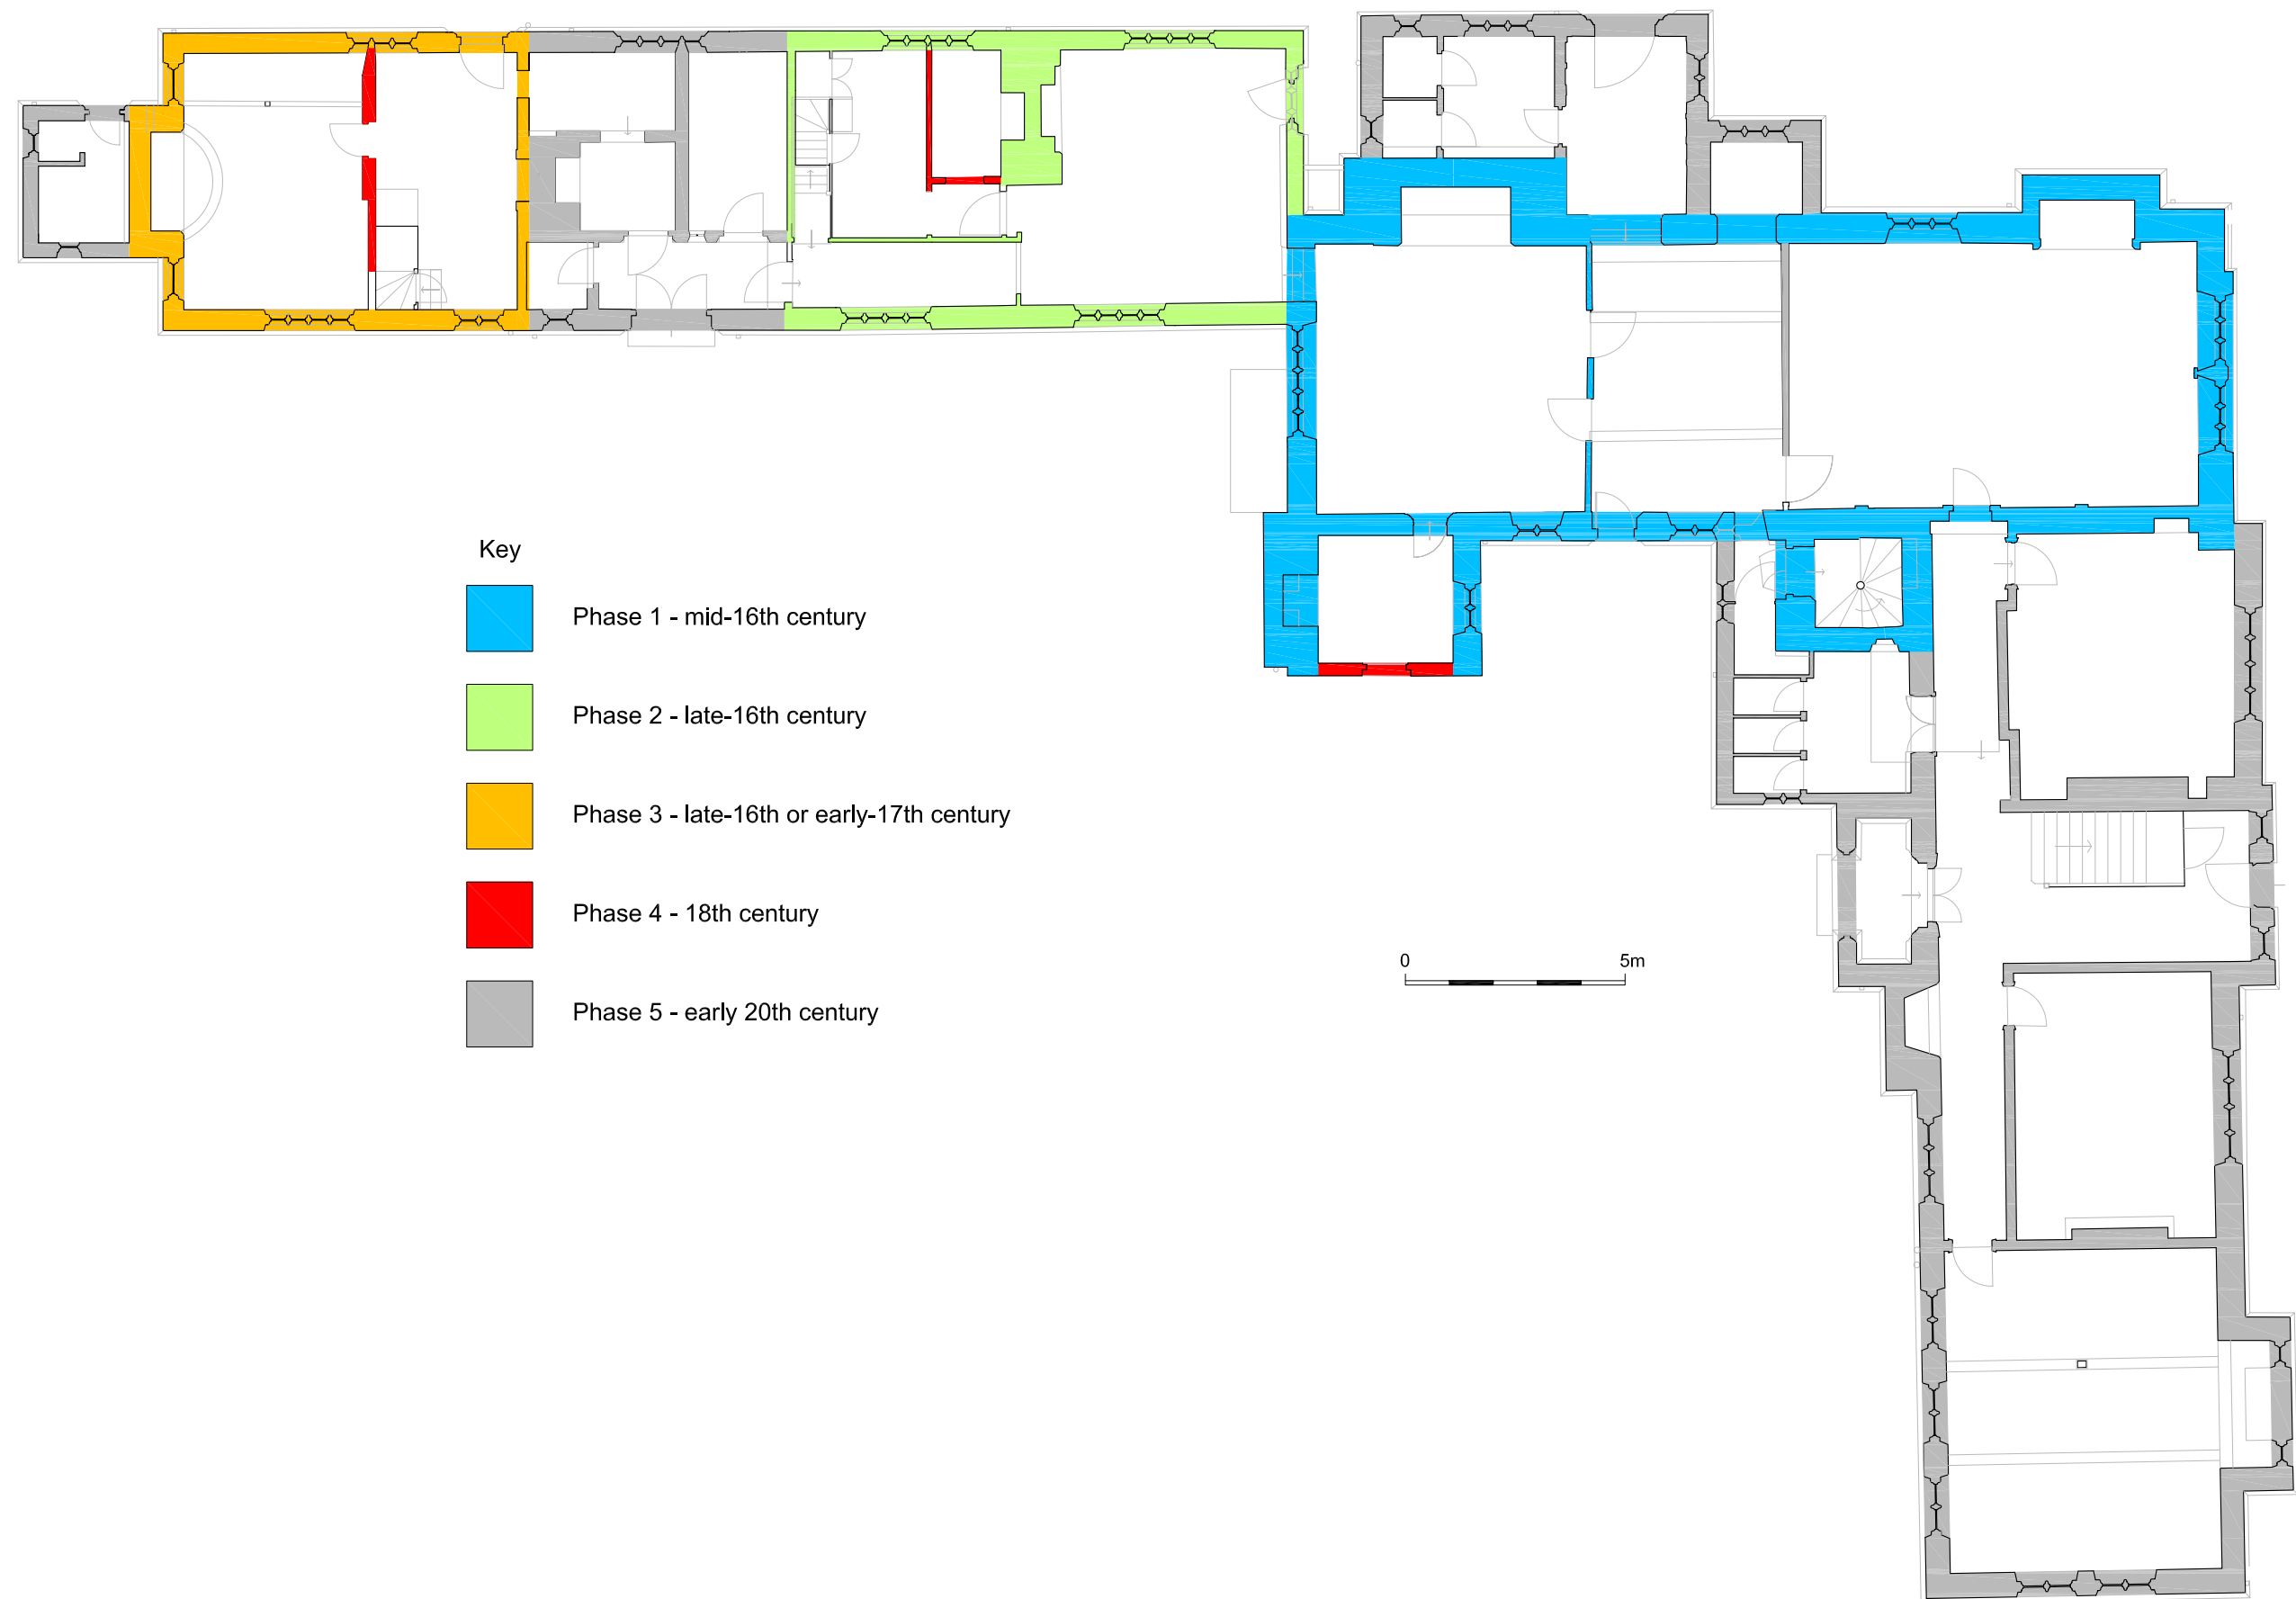
Figure 13

Phased ground-floor plan

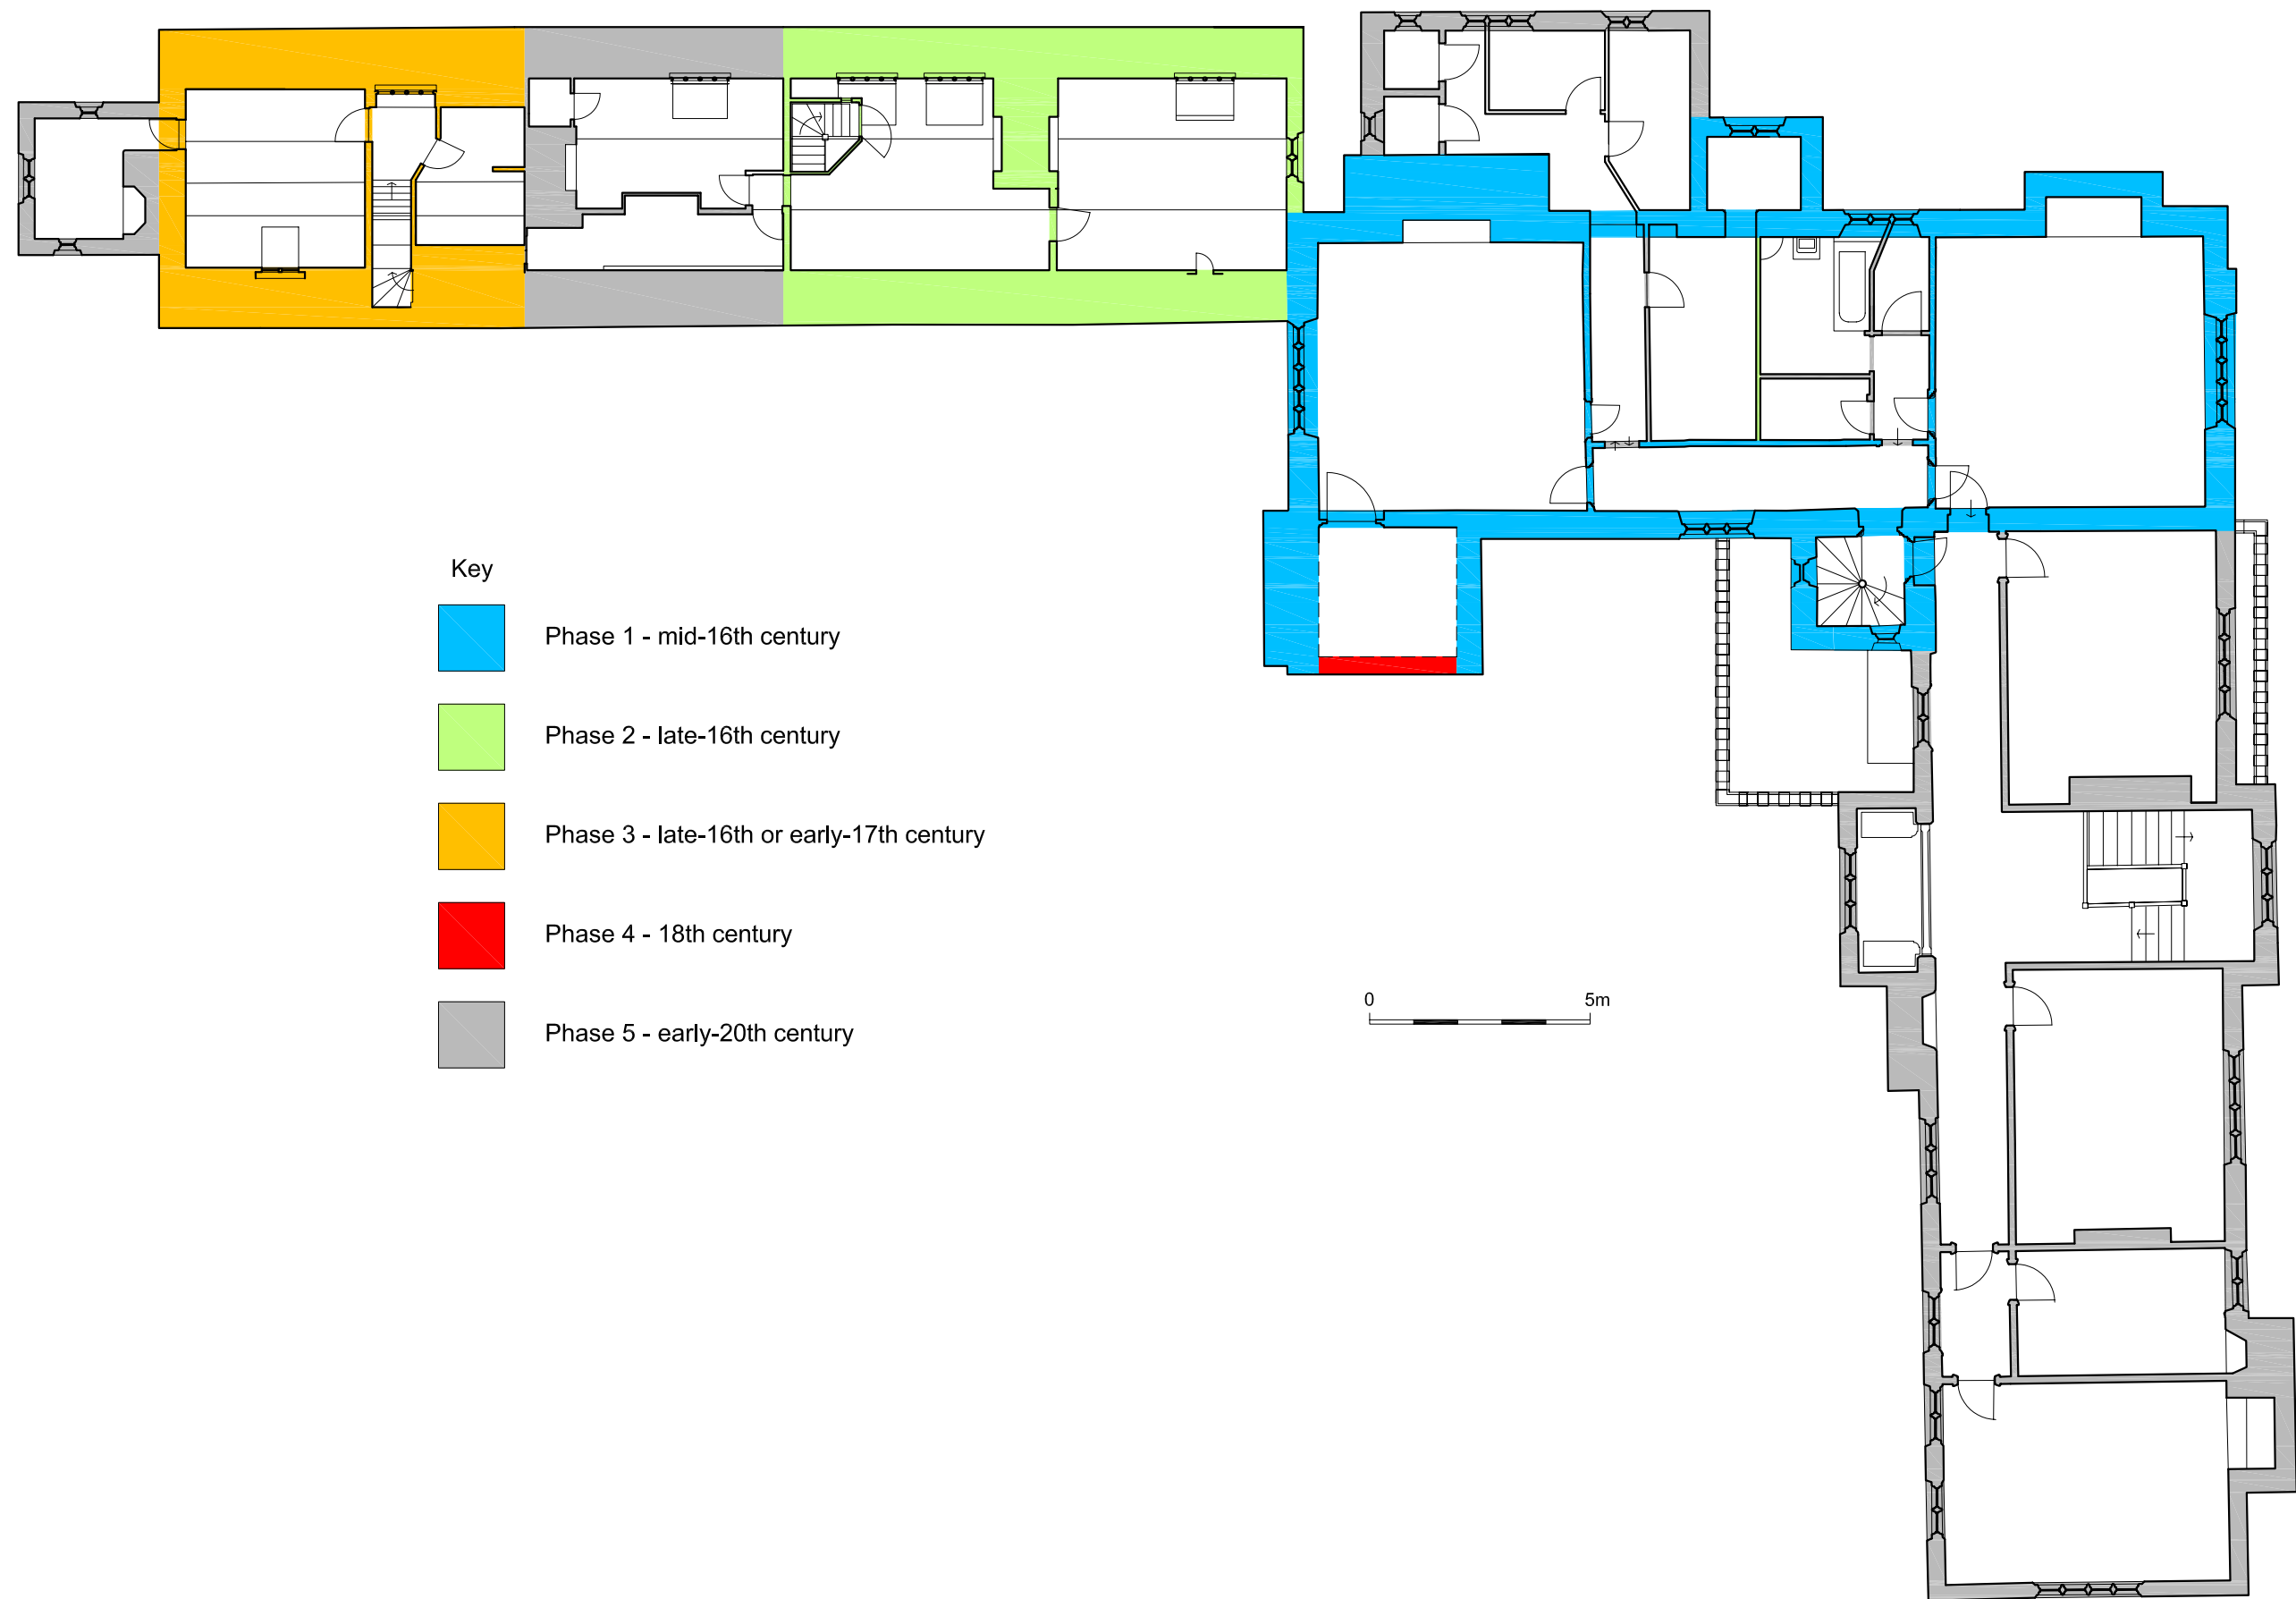
Figure 15

Phased first-floor plan
